Company	Trenz Electronic GmbH
PCN Number	PCN-20190112
Title	TEB0911-04-* SPI Flash and eMMC Change
Subject	BOM change
Issue Date	2019-09-09

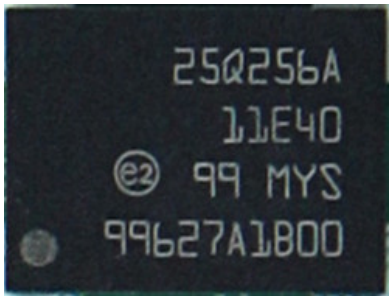
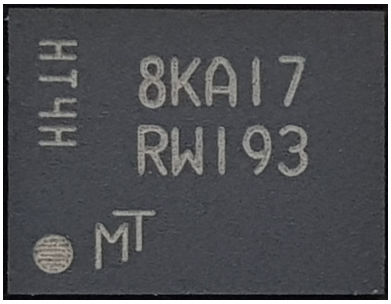
Locate Flash (U24, U25) on top side of PCB and eMMC (U26):

old	new
N25Q512A11G1240E	MT25QU512ABB8E12-0SIT
